Infrared Survey

Qualitative Infrared Thermographic Survey of Electrical Switchgear

Sample Report

Texas Inspected | Infrared Plus
661 E. Main Street #200-139,
Midlothian, TX 76065
972.292.8733
scott@texasinspected.com
6/28/2013

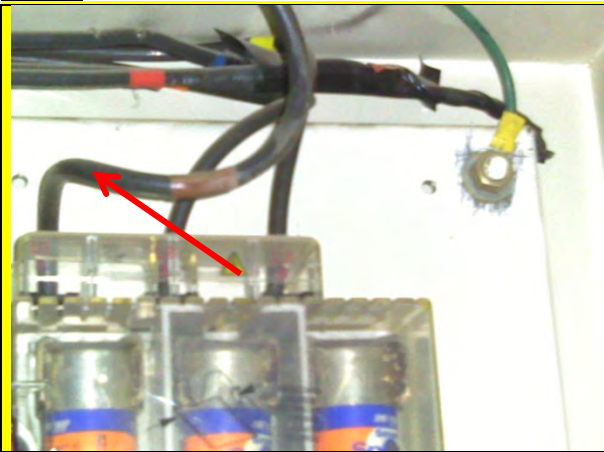
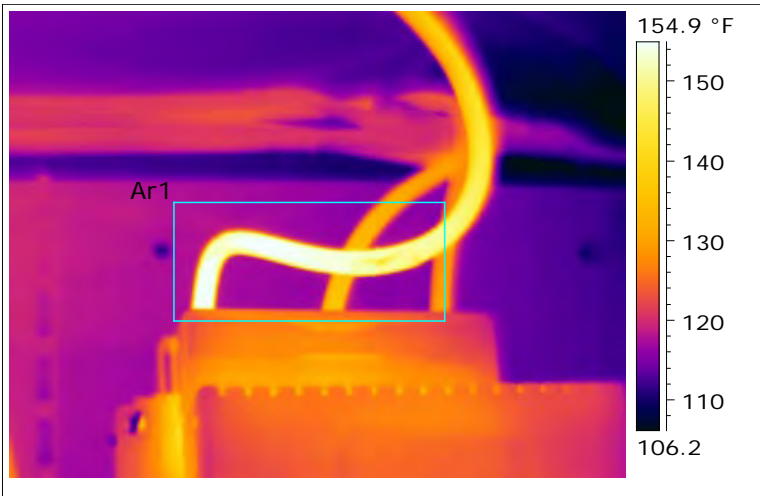
Item 1

Item Number	1
Location	Kiln 7
Equipment	Upper Cabinet
Reference Temp.	135 °F
High Temp.	157 °F
Temperature Rise	22 °F
Fault Rating	Minor

Description: The left phase connection was 22 degrees higher than the other phases.

Recommendation: Have control panel evaluated by electrician to determine if the load is too high or the connection is loose.

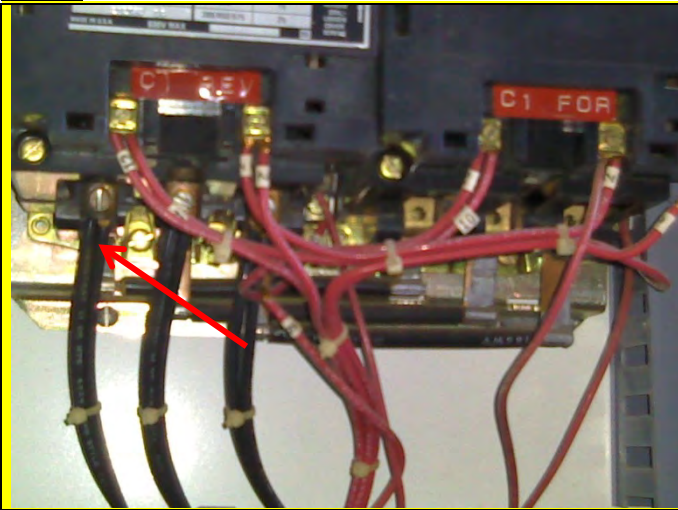
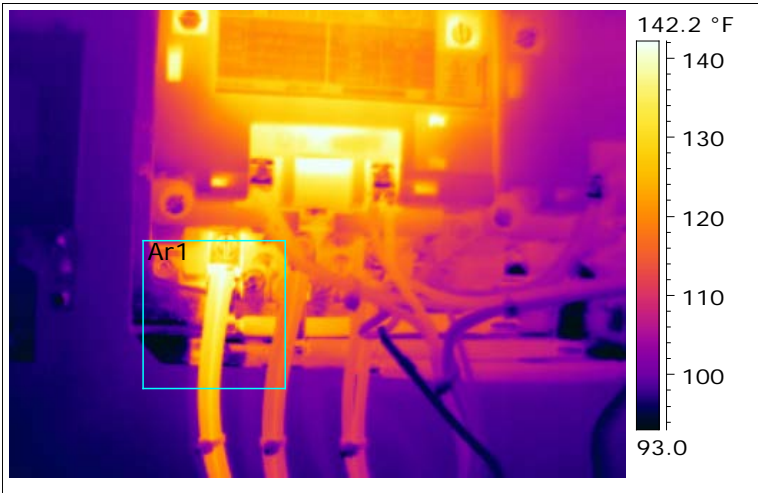
Item 2

Item Number	2
Location	Kiln 9
Equipment	Control Panel
Reference Temp.	120°F
High Temp.	140 °F
Temperature Rise	20 °F
Fault Rating	Minor

Description: The left connection was 20 degrees higher than the other connections.

Recommendation: Have control panel evaluated by electrician to determine if there is a load issue or the connection is loose.

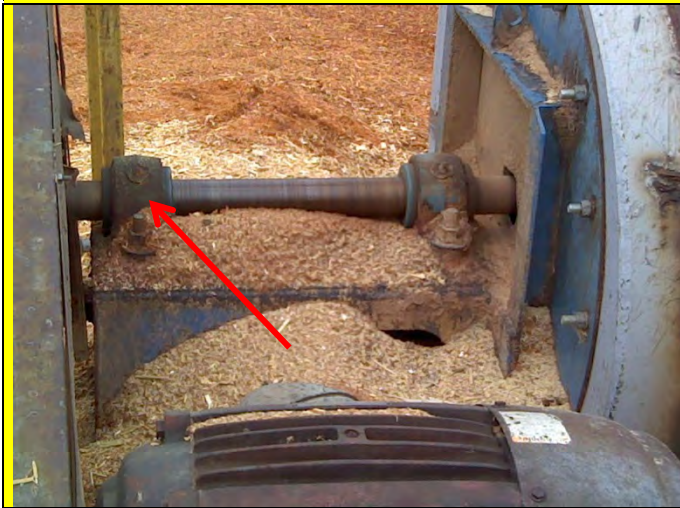
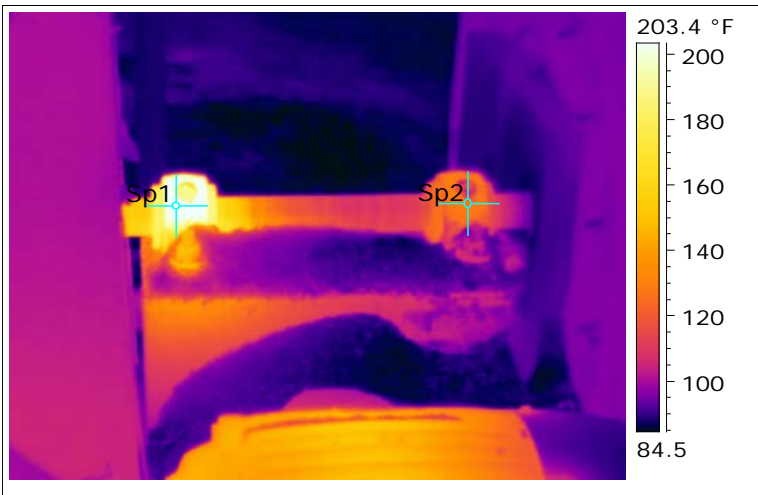
Item 3

Item Number	3
Location	Dust collector
Equipment	Bagger Bearing
Reference Temp.	127 °F
High Temp.	204 °F
Temperature Rise	77 °F
Fault Rating	Serious

Description: The drive side bearing was 77 degrees higher than the non-drive side bearing.

Recommendation: Replace bearing ASAP to prevent equipment failure and downtime.

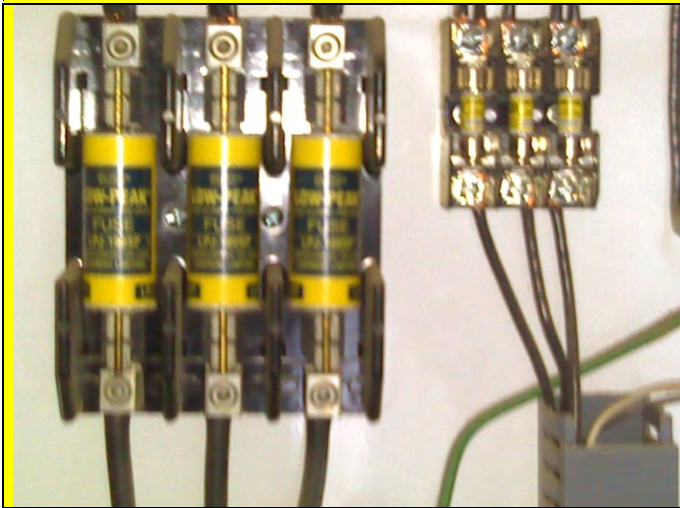
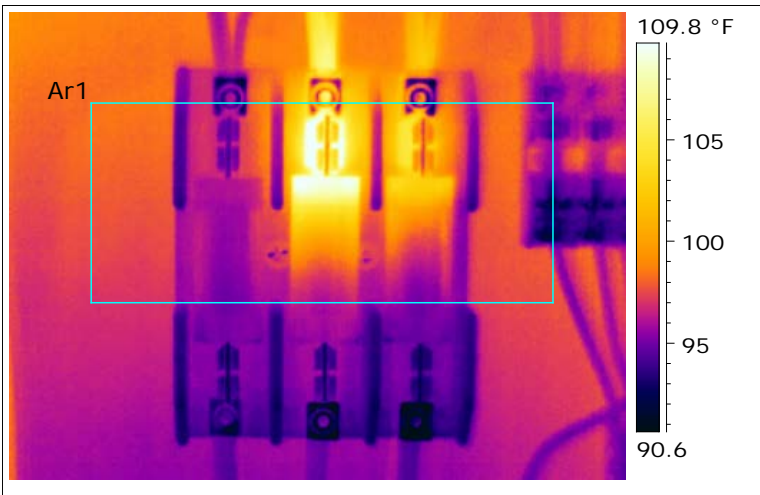
Item 4

Item Number	4
Location	Kiln 1
Equipment	MCC
Reference Temp.	96°F
High Temp.	107 °F
Temperature Rise	11 °F
Fault Rating	Minor

Description: The middle fuse connection was 11 degrees higher than the other fuse connections.

Recommendation: Have electrician check for loose connection.

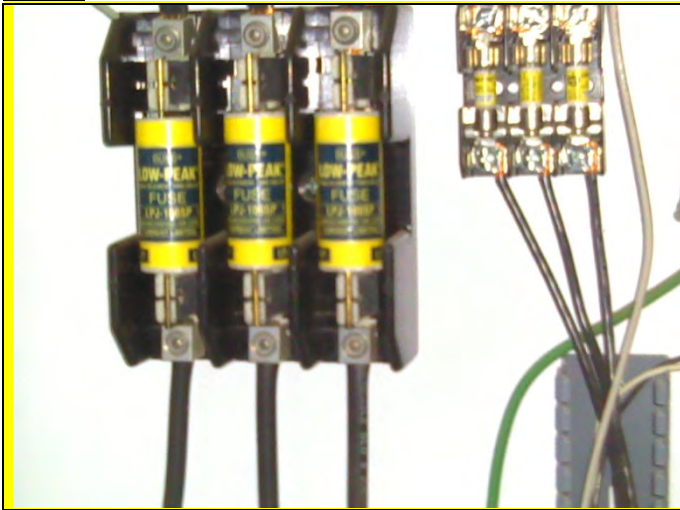
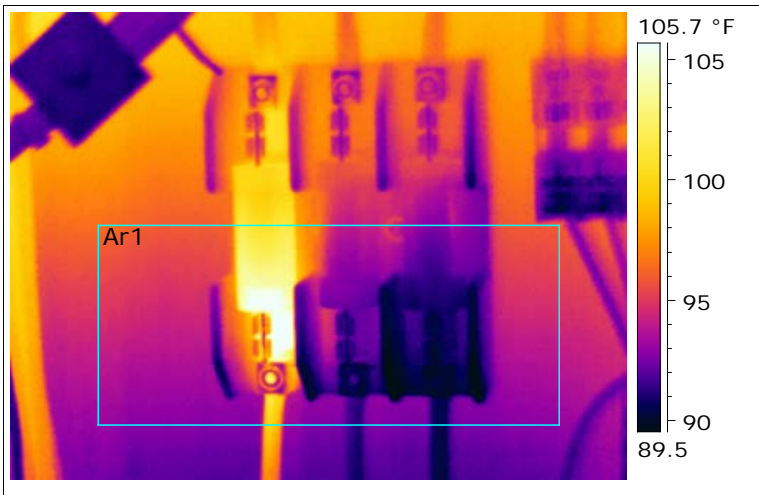
Item 5

Item Number	5
Location	Kiln 3
Equipment	MCC
Reference Temp.	91°F
High Temp.	101 °F
Temperature Rise	10 °F
Fault Rating	Minor

Description: The left fuse connection was 10 degrees higher than the other fuse connections.

Recommendation: Have electrician check for loose connection.

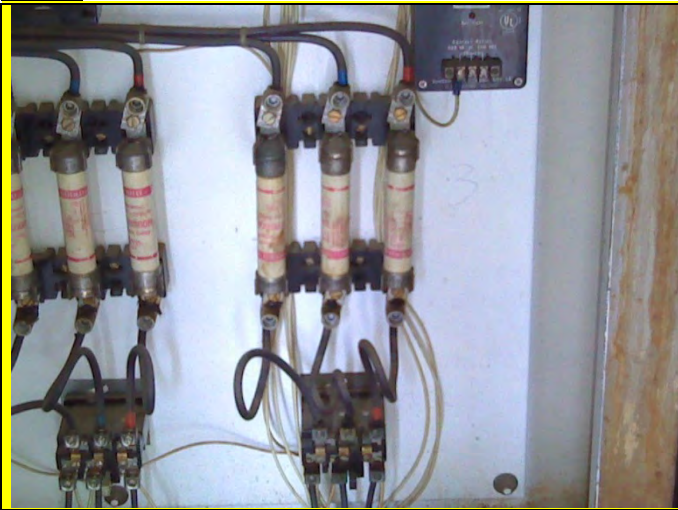
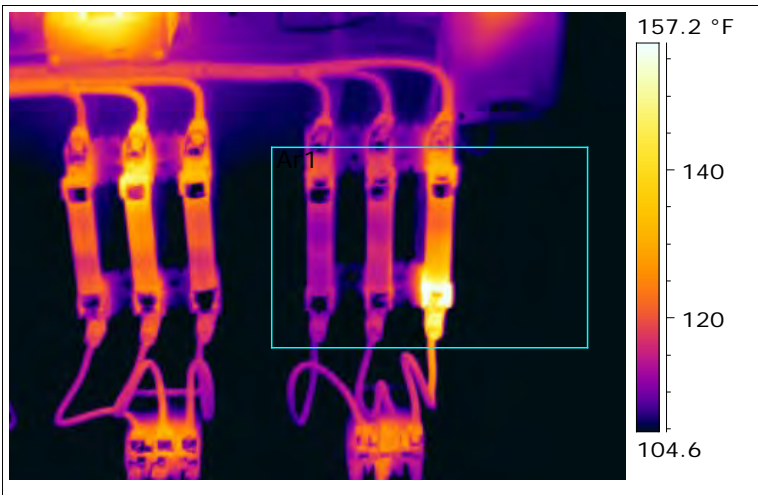
Item 6

Item Number	6
Location	Kiln 6
Equipment	MCC
Reference Temp.	111°F
High Temp.	132 °F
Temperature Rise	21 °F
Fault Rating	Minor

Description: The right fuse connection was 21 degrees higher than the other fuse connections.

Recommendation: Have electrician check for loose connection or issues with circuit.
